OFFICE OF THE INSPECTOR GENERAL

CITY OF BALTIMORE

Investigative Report Synopsis

OIG Case # 21-0032-I

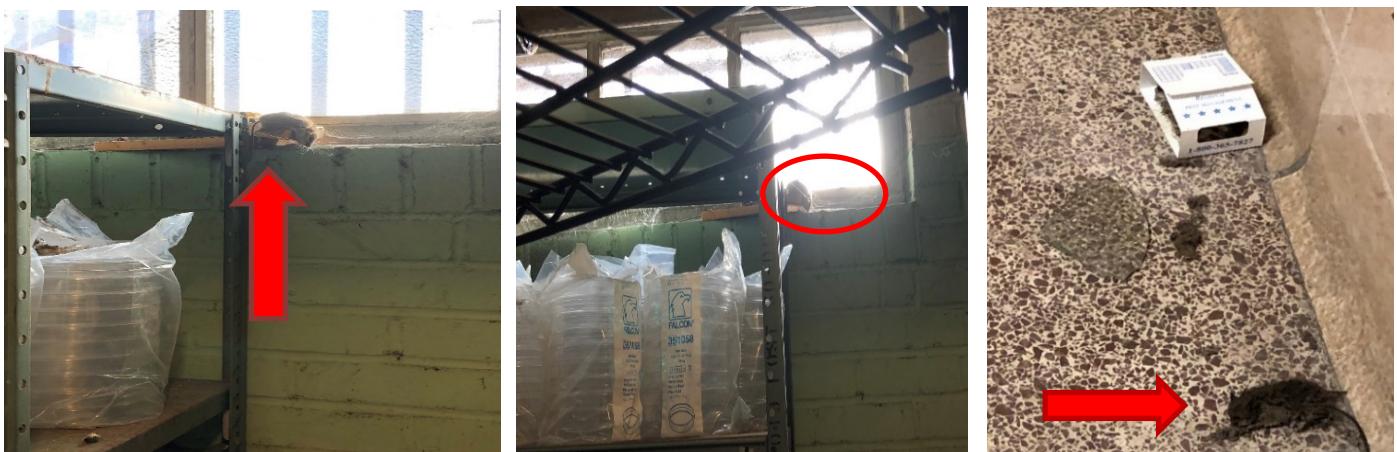
Figure 1: Rodents in basement and stairwell

Deceased rodents in the basement supply room and stairwell (Figure 1), accompanied by a foul odor, were notable observations.⁶ Additionally, deceased insects were observed in the supply room and basement areas (Figure 2). The OIG was able to confirm that in April 2021, BCDH employees communicated amongst each other about the dead rodent, seemingly in the same area of the basement the OIG observed in December 2020.

When asked about general maintenance and sanitation challenges at the Druid SHC, the BCHD manager stated that rodents have been an ongoing problem due to multiple factors, including the age of the building. According to a BCHD manager, a pest control vendor services the Druid SHC every two weeks, removing old traps and installing new traps. However, the separate BCHD janitorial services vendor refuses to remove the deceased rodents.

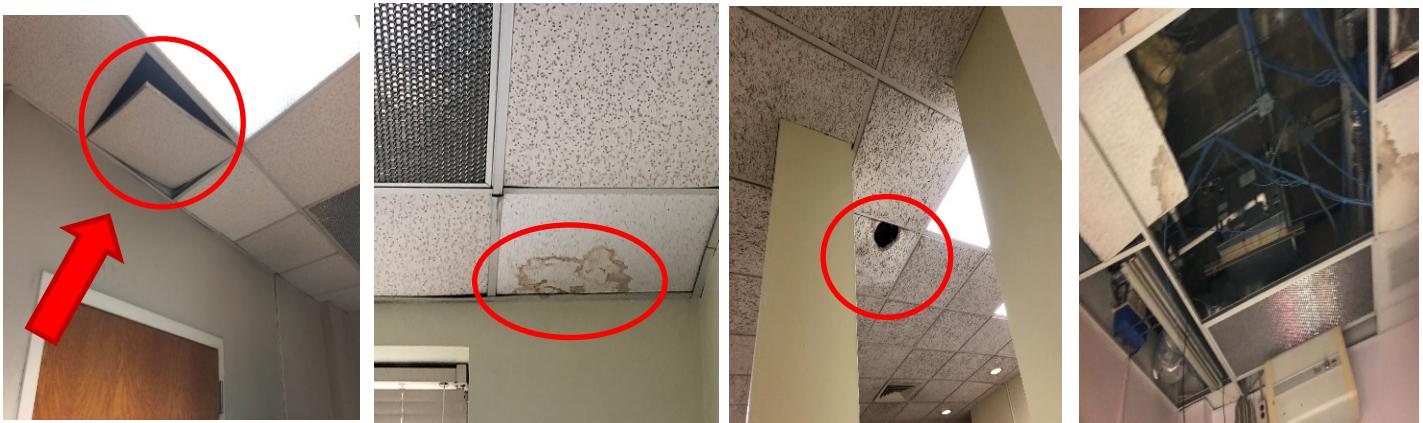
Figure 3: Damaged ceiling tiles in (from left to right) SHC hallway, Room 201, near the lab area, and room with computer server equipment/wires

In addition to rodents and insects, the OIG observed damaged or missing ceiling tiles (Figure 3) throughout the Druid SHC facility. Multiple witnesses told the OIG the Druid SHC's roof leaks, likely causing the observable water stains. The OIG also observed the door to the staff office area was unsecured and damaged (Figure 4).

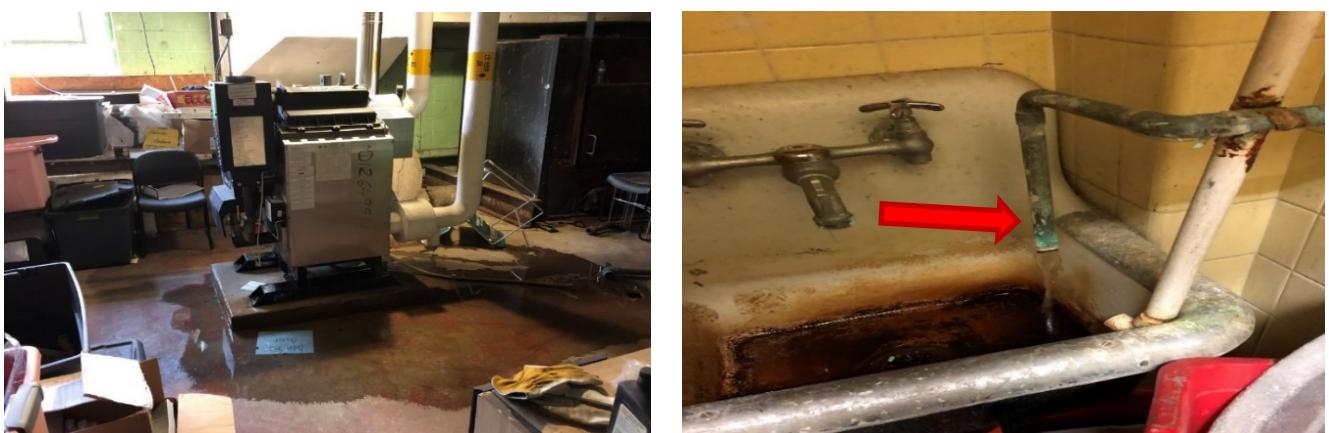
Figure 5: Water Leak in Basement (left) and running water pipe in the men's restroom closet (right).

The OIG also observed a water leak in the basement and a running water pipe in the men's restroom closet (Figure 5). According to the BCHD employee who was on site, no one was aware of the basement leak until the site visit, and although the running water in the men's restroom is a nuisance, it did not impact operations.

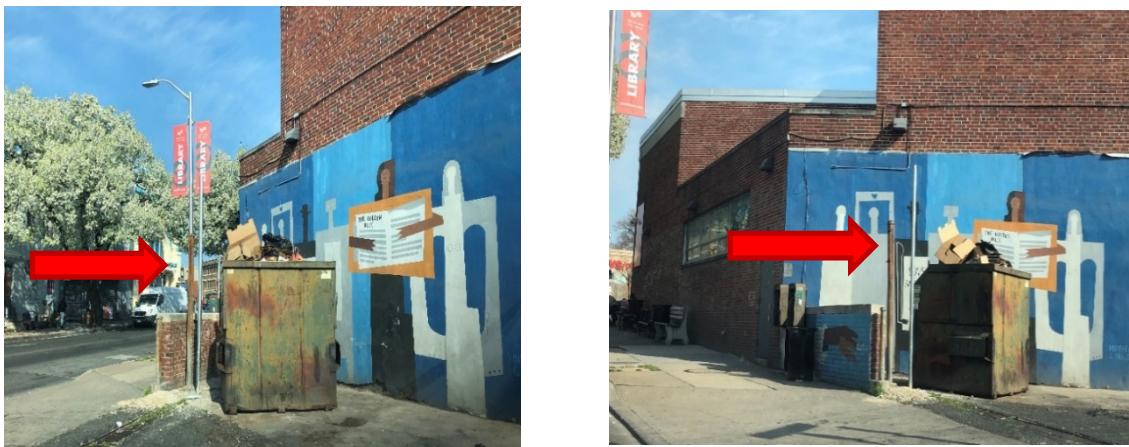
Figure 6: Druid SHC Dumpster

Additionally, the BCHD manager stated the Druid SHC's dumpster is frequently overfilled, creating a rat infestation outside the building. Despite prohibitions, residents and businesses from the surrounding area discard their trash in the dumpster, causing it to overflow. An OIG photo of the Druid SHC dumpster in April 2021 shows it filled to capacity (Figure 6). According to the BCHD manager, there have been discussions about the dumpster problems with the Department of General Services (DGS), who has agreed to assist with installing a fence to limit the public's access to the dumpster, and with the Department of Public Works (DPW), who agreed to pick up the trash twice a week.

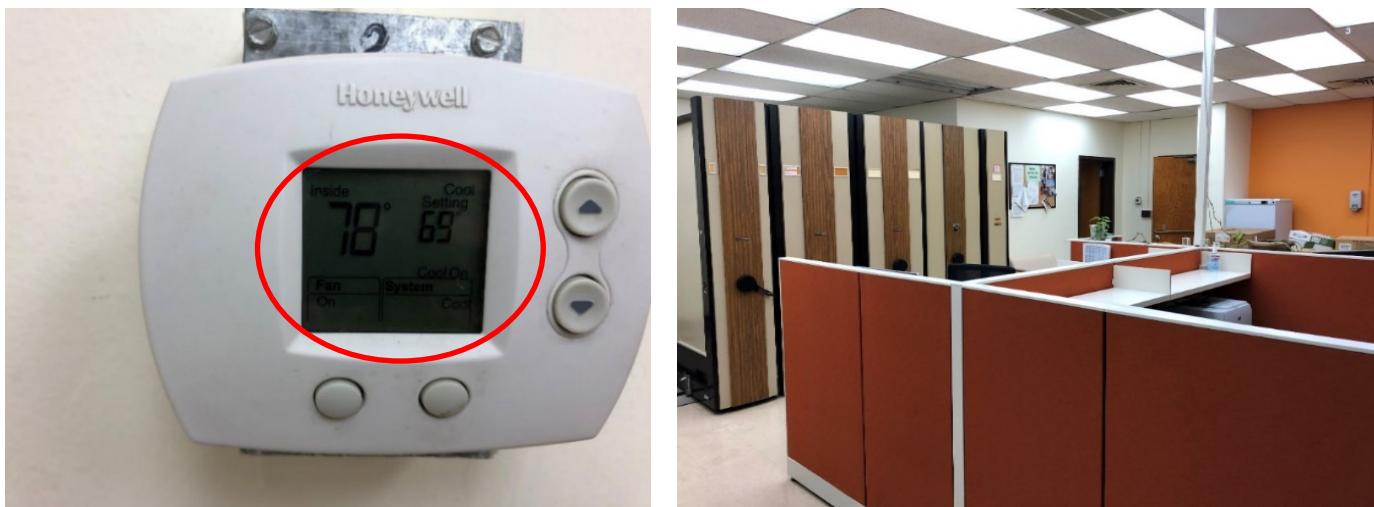
Figure 7: Room temperature higher than thermostat setting (left) and SHC staff office area where thermostat is located (right)

During the investigation, several SHC personnel alleged that the heating, ventilation, and air conditioning (HVAC) system does not properly regulate the temperature throughout the Druid SHC.⁷ These SHC personnel stated the temperature inside the Druid SHC can become extremely hot. One BCHD employee reported the indoor temperature to be 90°F on a workday in March 2021. During the OIG site visit to the Druid SHC, the office temperature was higher than the thermostat setting in the staff office area (Figure 7).

Multiple Druid SHC personnel reported instances when rapid testing for Human Immunodeficiency Virus (HIV) and Hepatitis C Virus (HCV) were halted due to the high building temperatures. Relevant correspondence obtained by the OIG suggested extreme temperatures could cause inaccurate test results or otherwise impact proper storage of the test kits. According to the manufacturer's test guidelines, the recommended storage temperature for the Rapid HIV tests is between 35°F and 80°F; the recommended storage temperature for the Rapid HCV tests is between 36°F and 86°F. If the tests are stored outside of these ranges, the kit controls must be run to ensure the tests are working sufficiently.⁸

According to the BCHD manager, the Druid SHC's laboratory needs a separate HVAC system from the rest of the building in order to maintain a consistent temperature for testing operations. The BCHD

manager said that they have requested HVAC upgrades as part of the City's Capital Improvement Program (CIP).⁹ This request is reflected in correspondence between BCHD and DGS.
