Investigative Report Synopsis

OIG Case #25-0011-I

On August 30, 2024, the Office of the Inspector General (OIG) received a complaint regarding unsafe and unsanitary work conditions at a Baltimore City Recreation and Parks (BCRP) office site located at 2100 Washington Boulevard, Baltimore, MD 21230.

Site Visit Carroll Park BCRP

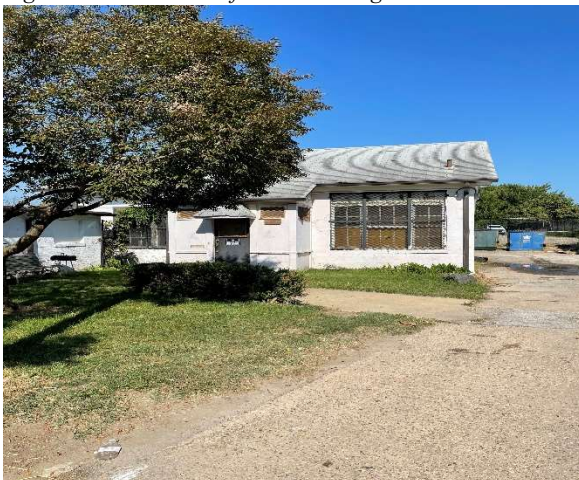
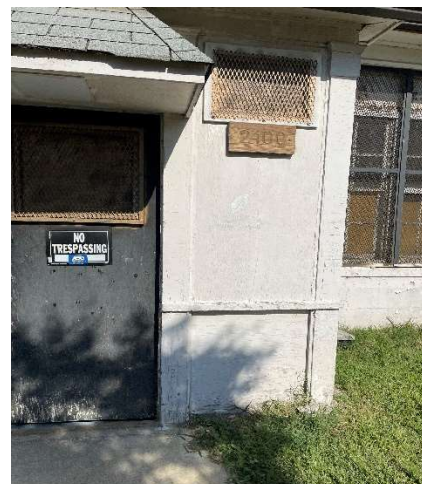
Figures 1&2: Outside of 2100 Washington Blvd.

The OIG conducted a site visit to the BCRP facility on September 11, 2024 (Figures 1&2).

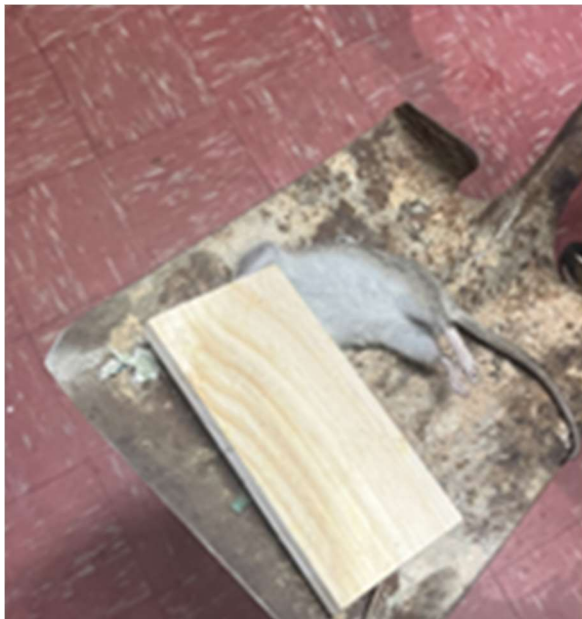
The OIG learned from employees that the facility has had an ongoing rodent infestation. The employees stated they do their best to clean the office and often sweep up rat droppings. The employee stated that the rodent issue was reported to the Department of General Services (DGS). The OIG obtained various photos of rodents previously captured by BCRP employees (Figures 3-6). The OIG reviewed metadata from the photos that appear to show when the pictures were taken.

Figure 3: Deceased Rodent (Metadata May 28, 2024)

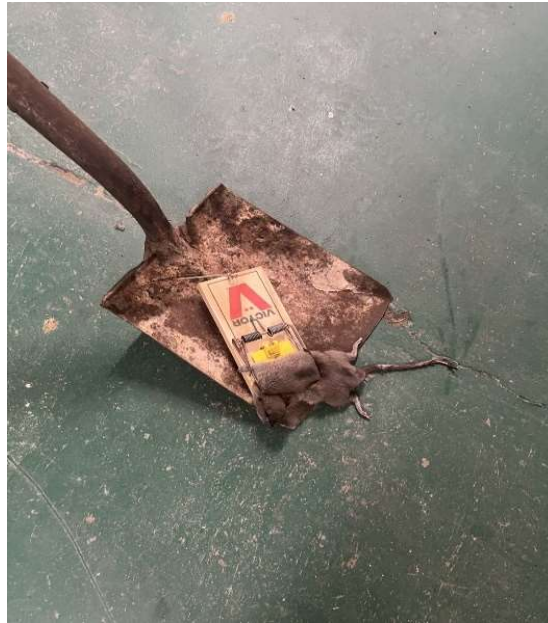
Figure 4: Deceased rodent (Metadata June 3, 2024)

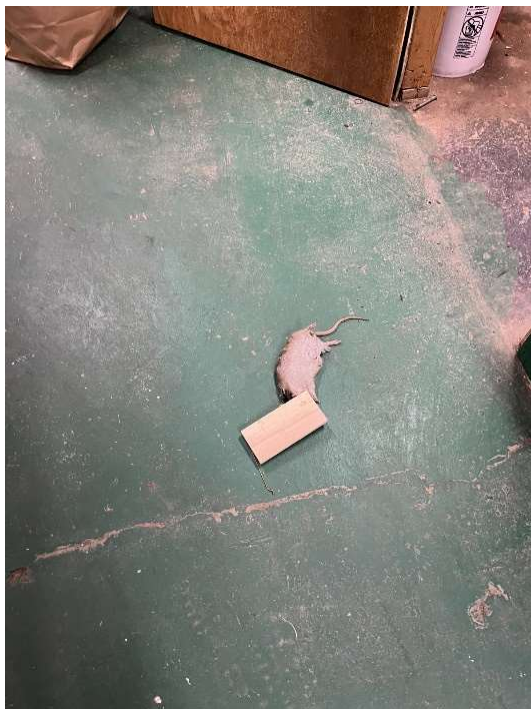
Figure 5: Deceased rodent (Metadata June 10, 2024)

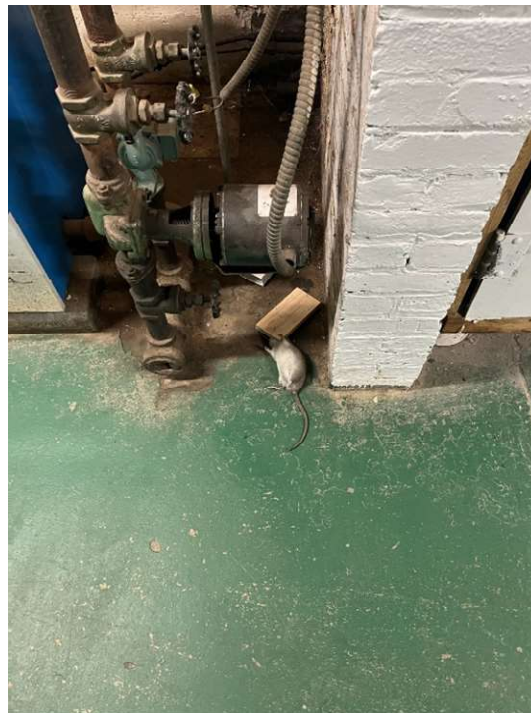
Figure 6: Deceased rodent (Metadata September 9, 2024)

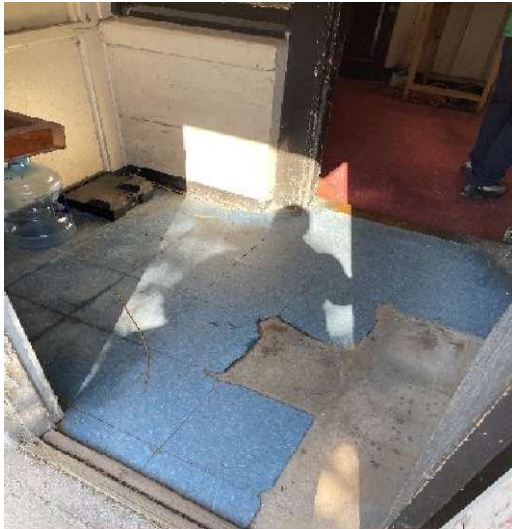
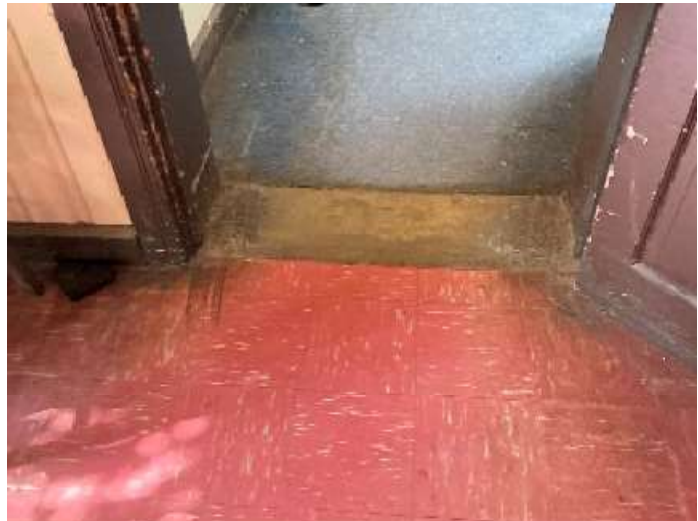
The OIG observed missing floor tiles at the facility's entryway (Figures 7&8).

Figures 7&8: Missing floor tiles at the entrance of the office building

- **Missing floor/ceiling tiles and exposed ceiling insulation:** Repair in progress - ceiling tiles completed; flooring tiles scheduled for completion on 10/4/24.
- **Broken door panel, taped window, exposed electrical wiring, and wall panel with exposed wires:** SR#s 24-00858136, 24-00858142, 24-00858146 created and schedule for completion on 10/4/24.
- **Blocked/padlocked exit doors:** SR# 24-00683891, 24-00683898 created; awaiting contractor estimate.
- **Garage issues (lock, ceiling tiles):** SR# 24-00830503 created; awaiting contractor estimate.
- **Stacked tires, empty water containers, and unsecured snow equipment:** Remediation in progress-coordinating recycling and litter removal, with all necessary equipment secured.

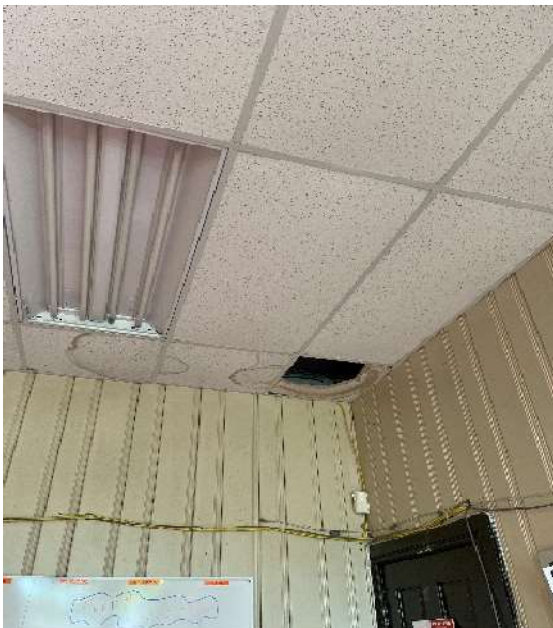
An employee reported that roof leaks have occurred, possibly causing the water stains in the printer room's ceiling tiles (Figure 9). Further, an employee mentioned instances of falling ceiling tiles and a possible bee nest in the ceiling. The OIG observed dead bees or another type of insect in the light fixture (Figure 10).

Figure 9: Missing ceiling tiles and water stains

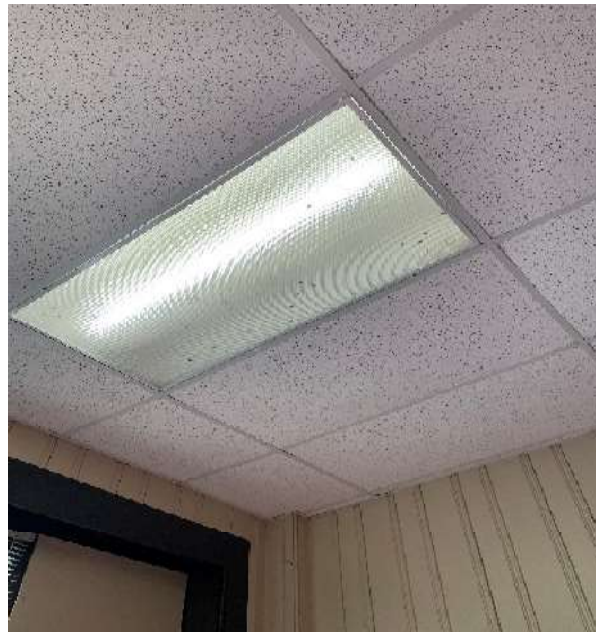
Figure 10: Deceased bees in light fixture

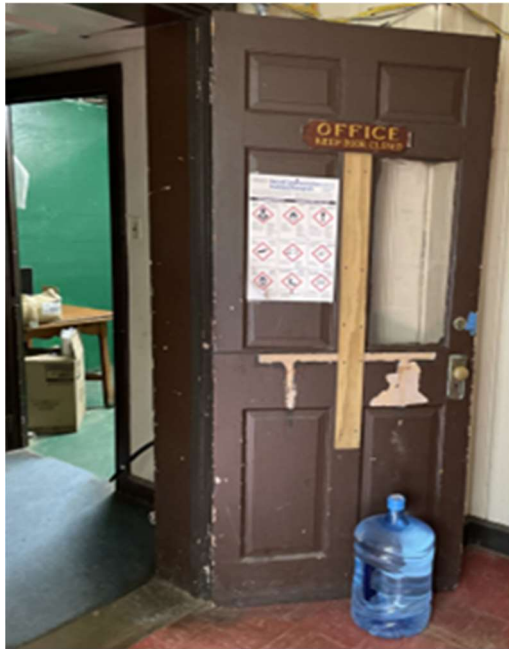
In the same printer room, the door to the staff break area was damaged (Figure 11). A windowpane appeared to be broken and repaired with black electrical tape (Figure 12).

Figure 11: Broken employee breakroom door panel

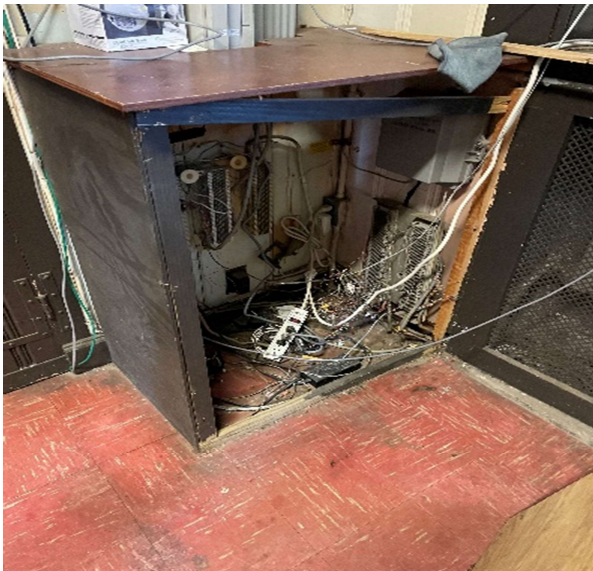
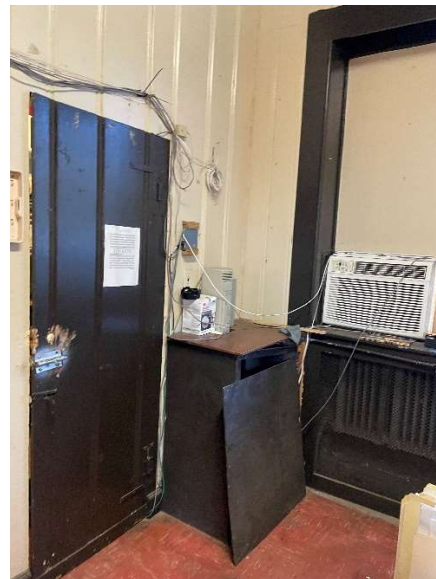
In an office area, the OIG noted partially exposed wiring where an air-conditioner was plugged in. An employee stated that the rats run through this area and chew the wiring (Figures 13-14). There were visible rodent droppings among the wires.

Figures 13&14: Exposed electrical wiring in the employee office

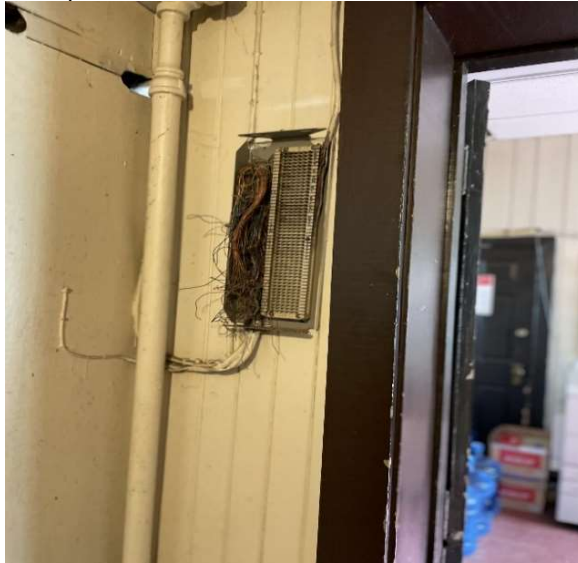
A wall panel outside an office door also had exposed wires (Figure 15).

Figures 15: Wall panel with exposed wires

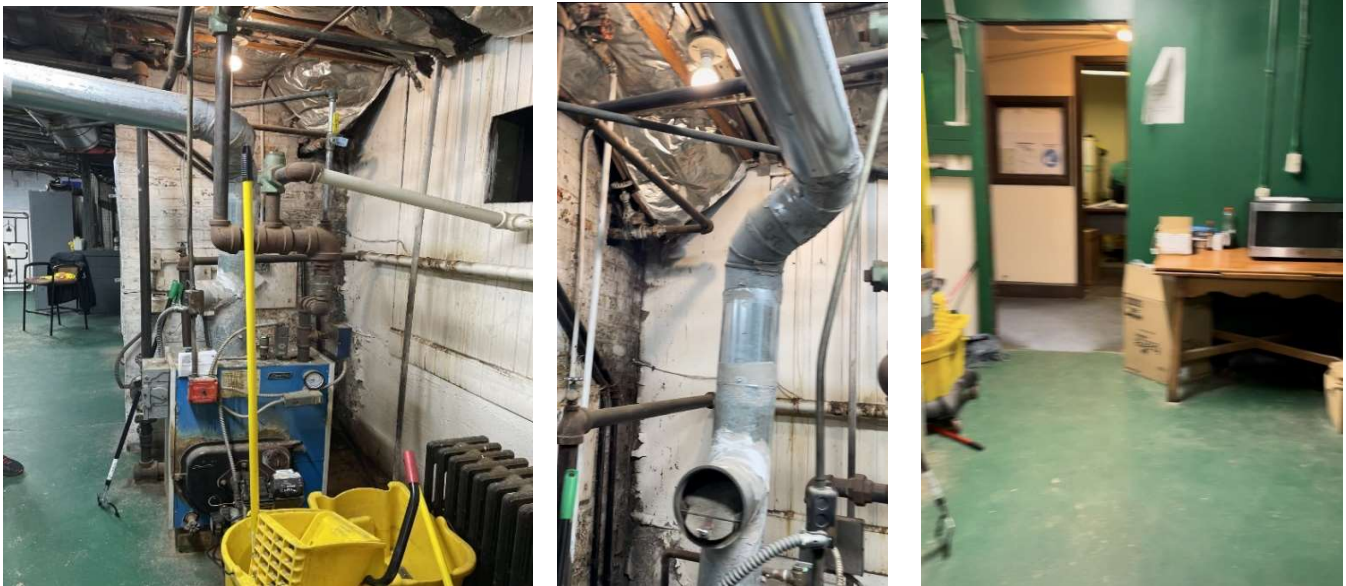
Exposed ceiling insulation was seen in the employee break area (Figures 16-18).

Figures 16-18: Exposed ceiling insulation in break room area

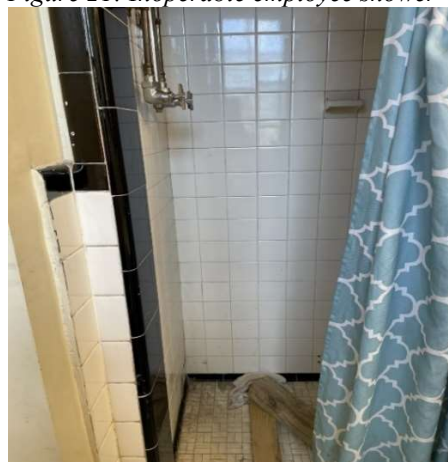
A BCRP employee informed the OIG that the shower is inoperable (Figure 21).¹

Figure 21: Inoperable employee shower

¹ This is a concern as the employee stated they plan to start using pesticides. A shower may be needed to comply with Environmental Protection Agency regulations regarding pesticide use. (<http://www.pesticideresources.org/wps/htc/htcmanual.pdf>)

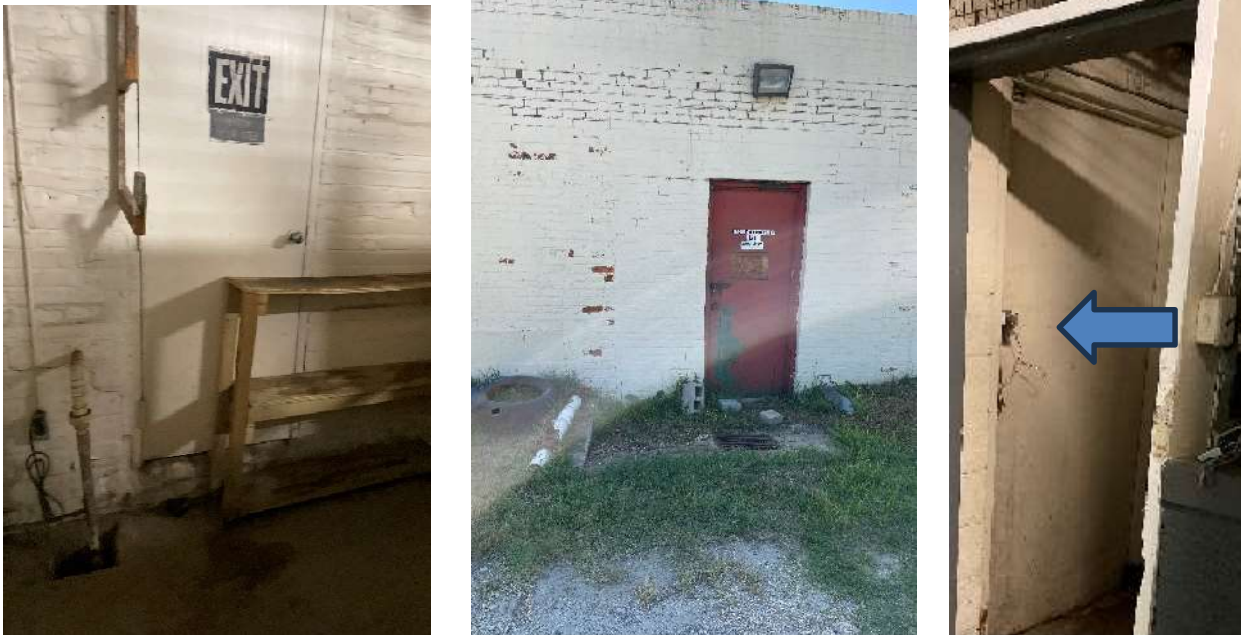
The exit door in the employee breakroom was blocked (Figure 22). The OIG also observed an exit door with a padlock on the exterior and a handle missing on the interior (Figures 23-24).

Figures 22-24: Blocked (left), padlocked (center and right) exit doors

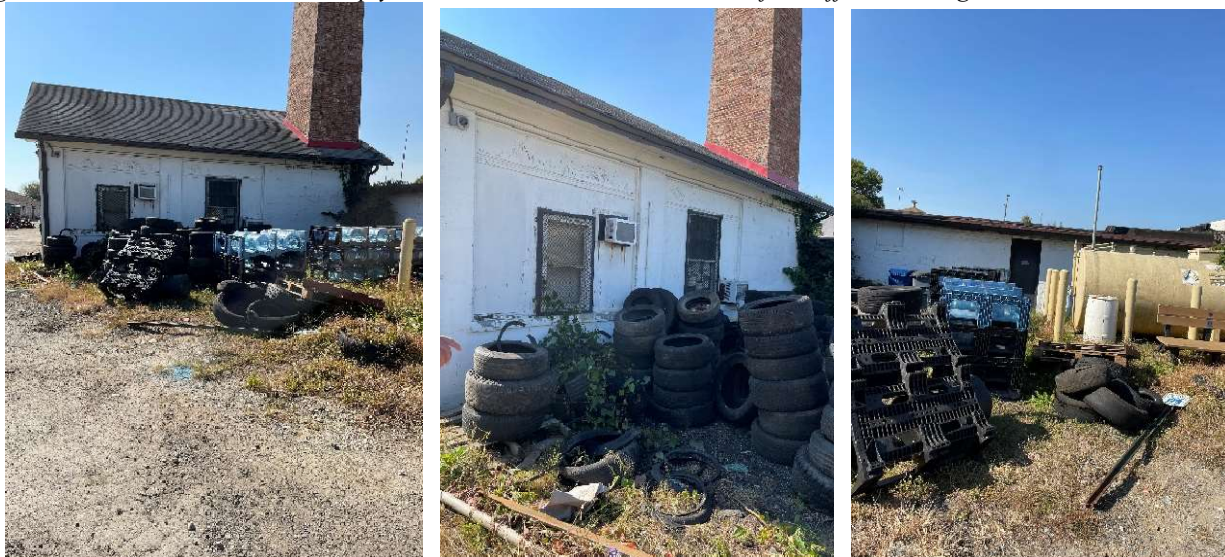
Outside the back of the facility were dozens of used tires and empty water containers (Figure 25-27).

Figures 25-27: Stacked tires and empty water containers on the exterior of the office building

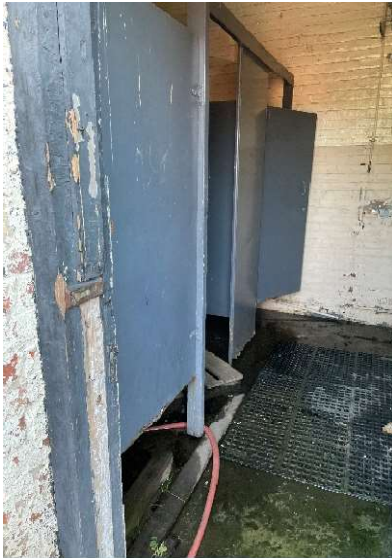
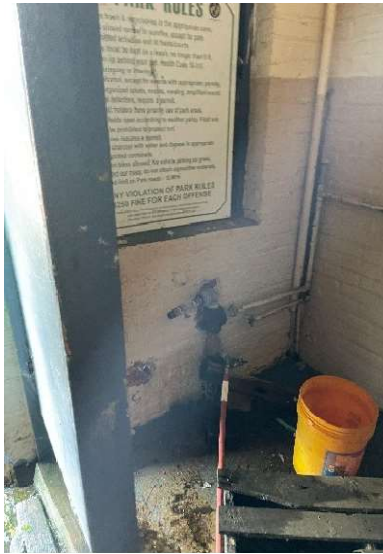
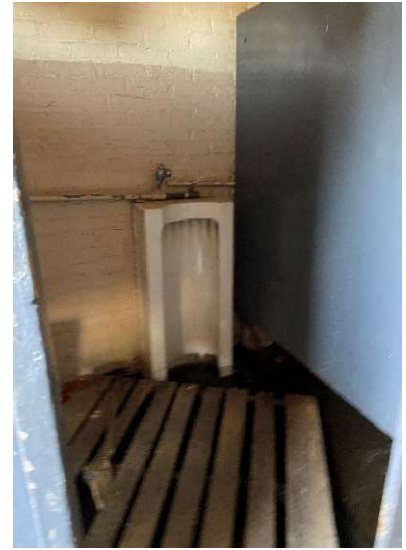
The exterior employee restroom in the garage area was inoperable, and the OIG observed a hose with water continuously running (Figures 28-30).

Figures 28-30: Employee external restroom & leaking hose

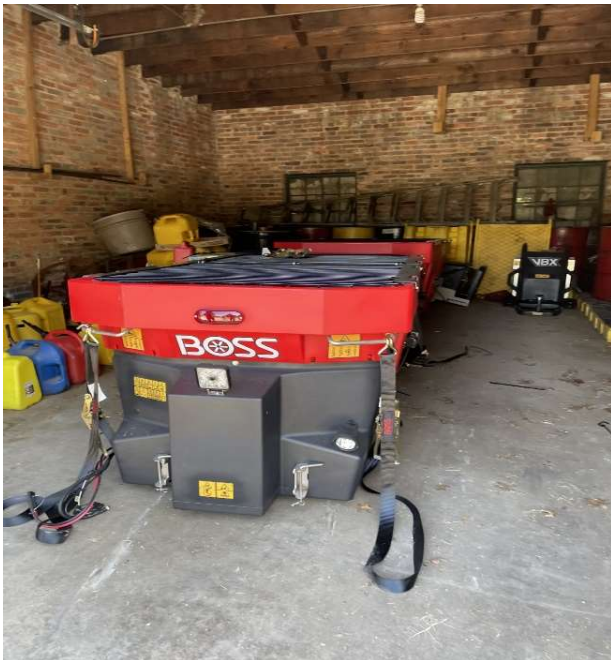
Equipment was stored in one garage that did not lock, potentially exposing it to theft (Figures 31-32).

Figures 31-32: Equipment inside of garage area (left), same garage area door without a lock (right)

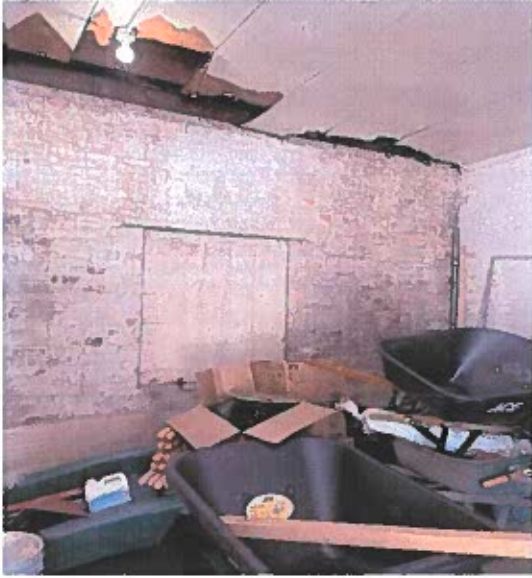
In another garage, ceiling damage and mildew odor was present (Figure 33). Snowplow materials were also stored in the open parking lot (Figure 34).

Figure 33: Garage with broken ceiling tiles

- **Power outages and breaker panel issues:** Repaired; full power restored.
- **Garage roof leak:** Repairs completed.
- **AC for garage and ventilation:** SR# 24-00830497 created; awaiting contractor.
- **Back door rodent entry:** SR# 24-00683891, 24-00683898 created; awaiting contractor.
- **Refrigerator replacement:** Purchase order submitted.
- **Soap dispenser mismatch:** New dispenser installed.
- **No kitchen sink:** SR# 24-00830492 created.
- **Water cooler replacement and Gatorade supply:** Water coolers received; awaiting Gatorade.
- **Outside bathroom renovation:** SR# 24-00830497 created; awaiting contractor.
- **Ballfield dirt section organization:** Contractor engaged; work in progress.
- **Garage bays and doors:** Cleaned and organized as of 9/23/24. SR# 24-00830503 created for garage doors.
- **Rodent control:** Monthly pest management treatments scheduled.
